AFAL-TR-75-112

K-RB LASER PUMP LAMP

TECHNICAL REPORT AFAL-TR-75-112 FINAL REPORT FOR PERIOD NOVEMBER 1978 — FEBRUARY 1975

AIR FORCE AVIONICS LABORATORY
AIR FORCE WRIGHT AERONAUTICAL LABORATORIES
Air Force Systems Command
Wright-Patterson Air Force Base, Ohio 45433

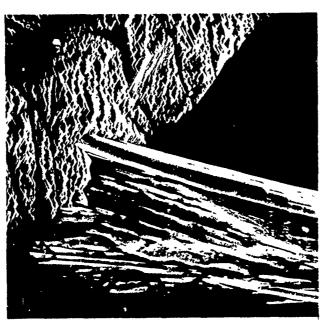
After 300 hours of operation, lamp No. 451 was dissected and its internal envelope surface examined with a scanning electron microscope (SEM). Hexagonal shaper crystallites containing aluminum and potassium (as determined by concurrent x-ray analysis) were found at the reaction sites. A representative SEM photomicrograph is shown in Figure 8.

Figure 8. SEM Photomicrograph of Envelope Frosting Site (500X)

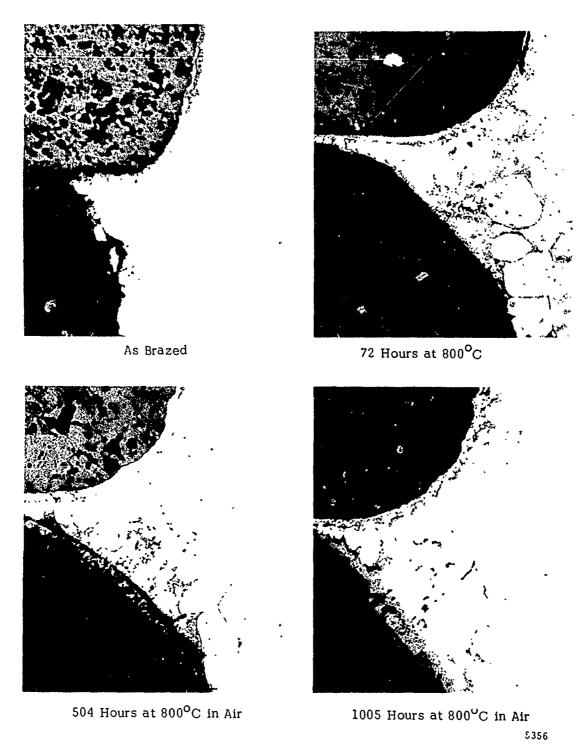
Since such seals in lamps would be operating at temperatures at least 100°C lower than the test temperature, would be approximately 70 mils wide, and would be exposed to an atmosphere relatively free of oxygen in ultimate space service, the results indicate that the seals would not fail from oxidation during lamp operation in the laboratory or in a satellite.

Figure 12. Photomicrographs of Ni/Al $_2{\rm O}_3$ Seals Before and After Oxidation Tests (Magnification 200%)

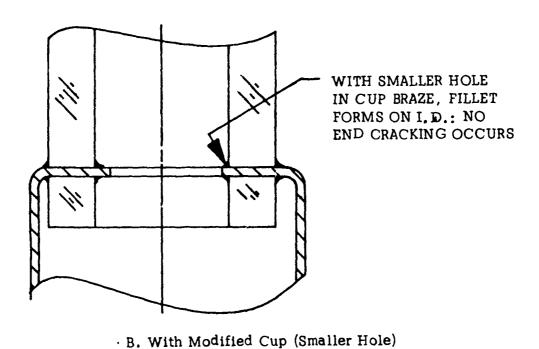
Figure 18. Cup Modification to Prevent Localized Envelope Cracking Due to Misalignment.

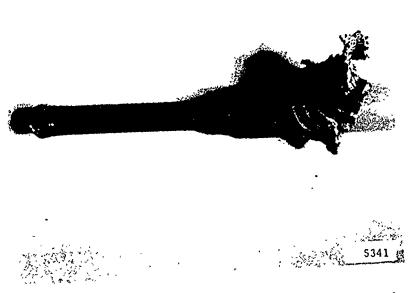
Figure 26. Specimen Coated With Fused Tin-Aluminide After Oxidation Tests

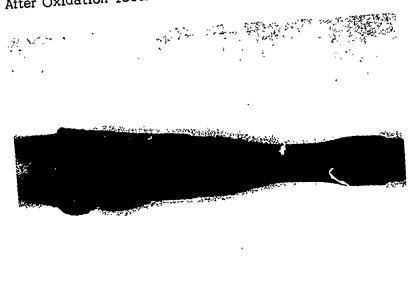
Figure 27. Specimen Coated With Fused Silicide After Oxidation Tests
